Quality Gonnection Dedicated to Quality Kia Vehicle Repairs

VOL. 11 | NO. 1 SPRING 2016 | Quality Connection is published by Kia Motors America

Painless Pane

Heeding a warning

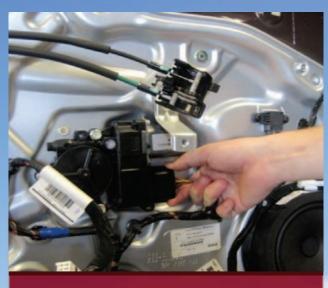
When the driver's side window is inoperable, it's a bit of an inconvenience. Fortunately, the remedy to fix it is easy. Some Sorento (XMa) vehicles, produced from January 28, 2010 through May 16, 2011, may exhibit this condition and warrant the replacement of the power window motor as outlined in this article.

- **1.** Turn the ignition to the off position and open the driver's side door.
- **2.** Remove the quadrant inner cover using a non-marring plastic remover. Caution: Exercise caution when removing the quadrant inner cover as it can be easily damaged.
- **3.** Push the lock pin to disconnect the tweeter connector.

- **9.** Remove the cap from inside the door handle and remove the screw.
- **10.** Remove the cap from outermost door panel mounting location and remove the screw.
- **11.** Use a non-marring plastic remover to dislodge the bottom edge of the door panel.
- **12.** Remove the door panel by gently pulling on the storage compartment.
- **13.** Push the hook and remove the inside handle cage.
- **14.** Disconnect the connectors from the door panel.
- **15.** Disconnect the power window motor connector and remove the bolts from the power window motor.
- **16.** Install the replacement power window motor by reversing the removal steps.
- **17.** Reinstall all other removed components by reversing the removal steps.
- **18.** Test the operation of the power window motor to confirm proper operation. KIA

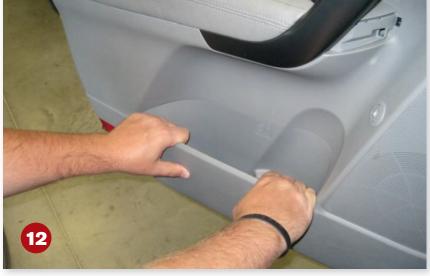
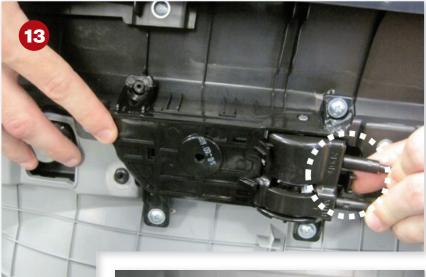
- **4.** Remove the door grip handle cover using a non-marring plastic remover.
- **5.** Remove the screw securing the upper portion of the door grip.
- **6.** Remove the screw securing the lower portion of the door grip.
- **7.** Remove the cover from inside door handle trim area and
- **8.** Remove the cover from innermost door panel mounting location and remove the screw.

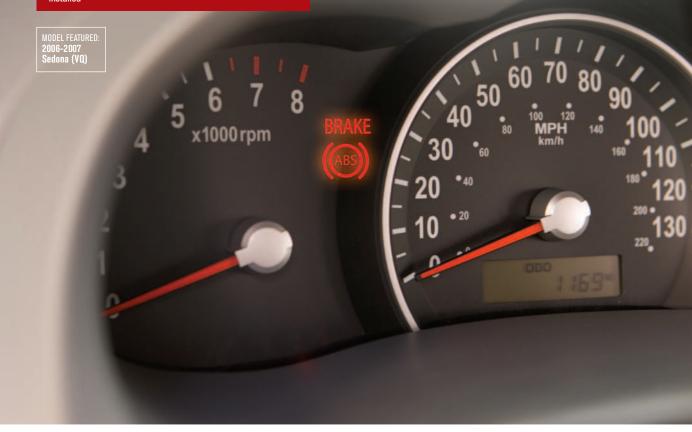
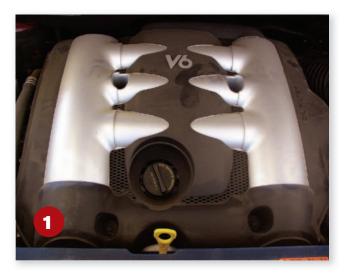
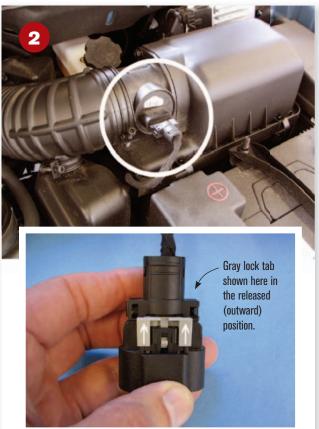
Ground point g19 - g20 is located behind ABS/ESC Unit on LH (driver's) side outboard panel.

Remove the four bolts from the engine cover and set it

Disconnect the Mass Air Flow Sensor's (MAF) electrical connector.

Note: Slide the gray colored lock tab slightly in the direction indicated by the arrows in the photograph, which will expose the release tab for the connector. If this is not done first, the MAF connector will be damaged.

Gray lock tab is shown here in the released (outward) position.

Loosen the hose clamps at the MAF and throttle assembly. Remove and lay aside the air intake hose as shown, so it's out of the way.

Release the two spring clips that attach the air filter assembly cover. Remove the cover (with MAF attached) and the air filter insert. This will allow better access to g19 and g20.

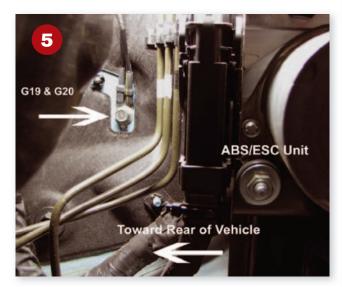
Locate the ground point for g19 and g20. It is located behind and close to the ABS/ESC unit on the lH (driver's) side outward panel.

Using a 1/4" drive ratchet, 14" extension and 10mm flex / swivel socket, reach behind the ABS/ESC unit to remove the g19 - g20 ground bolt.

You may need to insert your other hand over top of the ABS/ ESC unit (between the brake fluid reservoir and PCM) to guide the socket onto the bolt head.

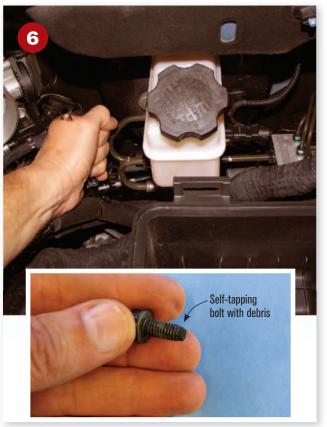
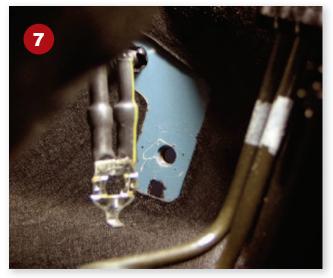
Reinstall the ground lug on the bolt and fully tighten the bolt to the body.

Note: Be certain that the hook on the ground lug is inserted into its mating hole when reinstalling the bolt. Otherwise, the ground lug may become deformed and not provide a proper ground.

Install all parts in the reverse order of removal. Clear any DTCs that may have been generated. Cycle the ignition key off, and then back on. Make sure the ABS/ESC light (MIL) turns on for the warning lamp check, and then turns off after several seconds. If the MIL comes back on, check for any stored DTCs and repair as necessary referencing the service information. KIA
