Quality Connection

SUMMER 2016 VOL. 11 | NO. 2

The Hex of Body Flex

Pop Goes the Seat

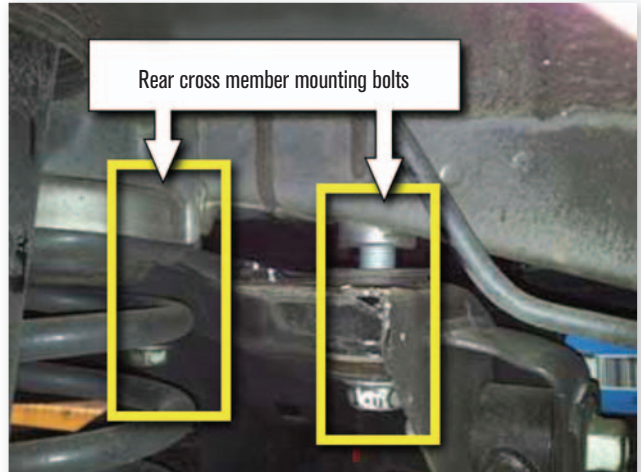
1

Rear cross member mounting bolts

1. Remove both rear wheels.
2. Remove the two rear upper shock mounting bolts (perform the repair one side at a time).
3. Lower the rear cross member (1.5 inches) by loosening the cross member bolts (perform the repair one side at a time).

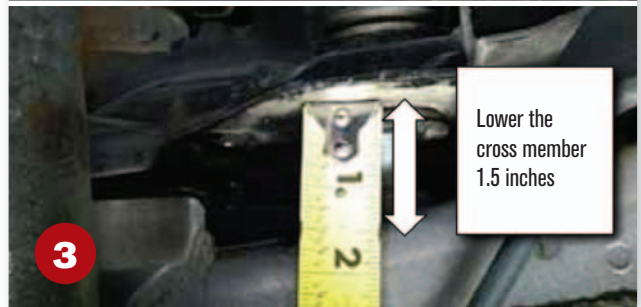
3

Lower the cross member 1.5 inches

Caution: Support the rear cross member by placing a transmission jack under the rear control arm before proceeding. Do not completely remove the rear cross member bolts, and only work on one side at a time.

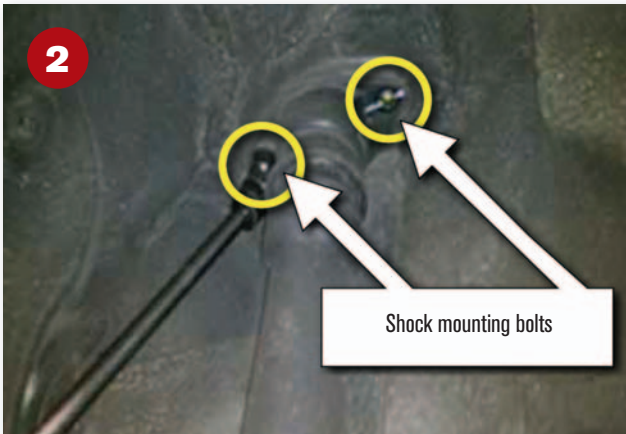
2

Shock mounting bolts

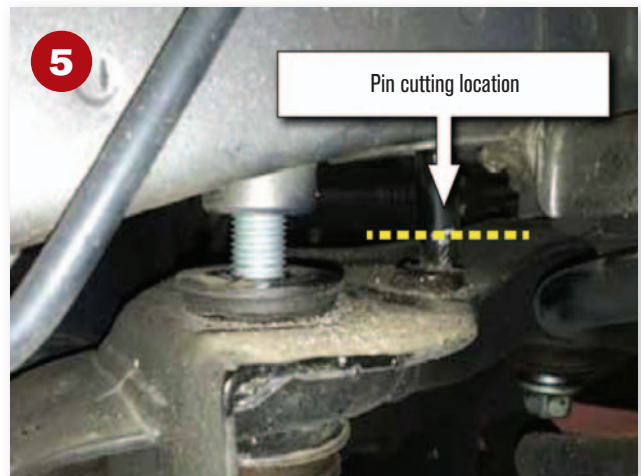
5

Pin cutting location

4. Locate the cross member alignment dowel pin.
5. Use a reciprocating saw, pneumatic metal saw or equivalent to remove the alignment dowel by cutting near the base of the pin (10mm maximum from the base).

Notice: Use a saw blade which is just long enough to reach the pin (5-inch blade). Be careful not to damage any other components. **Caution:** Be sure to use proper protective gloves/equipment when handling cut off tool.

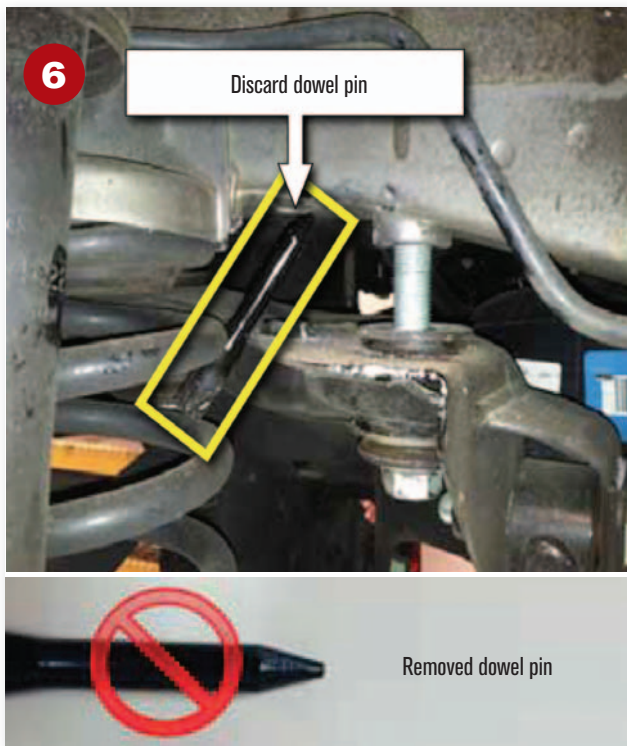
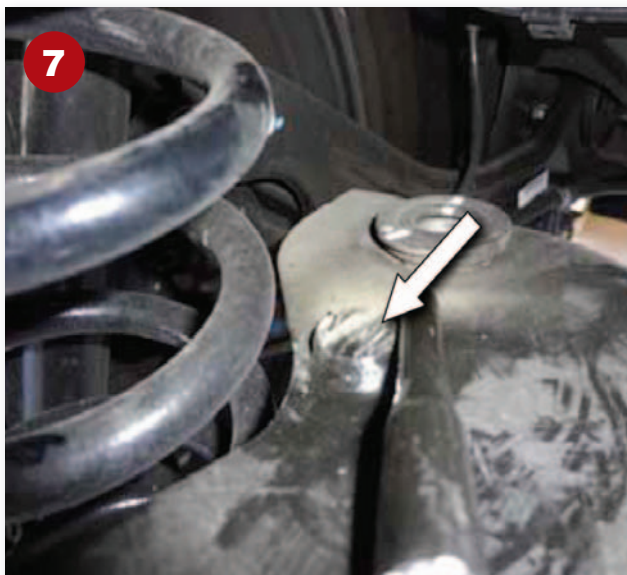
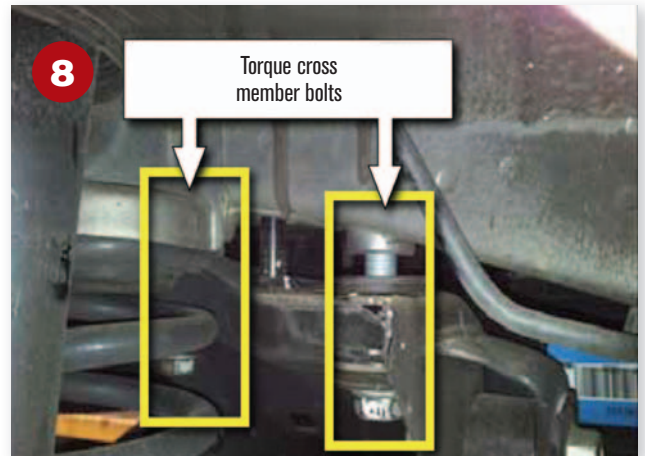
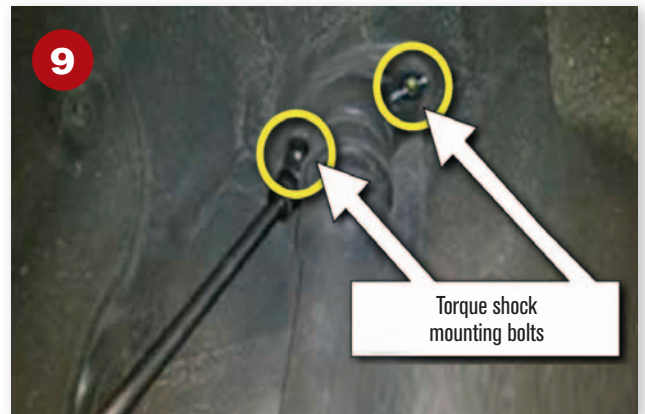
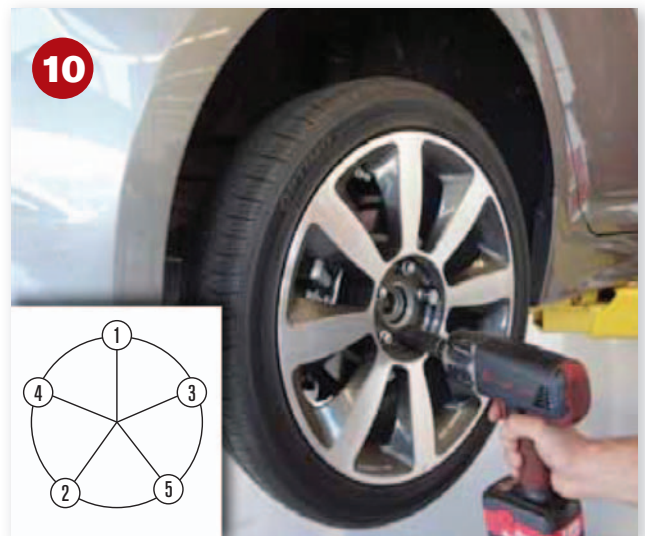
- 6.** Remove and discard dowel pin.
- 7.** Apply zinc spray or cavity wax to exposed area(s) to prevent corrosion/rust of the bare metal.
- 8.** Torque the two rear cross member bolts.
Cross member bolt torque specifications: 115-130 ft-lbs (156.9~176.5 Nm)
- 9.** Reinstall and torque the rear upper shock mounting bolts.
Shock bolt torque specifications: 36-63 ft-lbs (49.0~63.7 Nm)

- 10.** Reinstall the wheel on the repaired side using the star torque pattern as indicated in the photo insert. Wheel lug nut torque specifications: 65~79 ft-lbs (88.3~107.9 Nm). Repeat steps 1~10 for pin removal on the opposite side of the vehicle. **KIA**

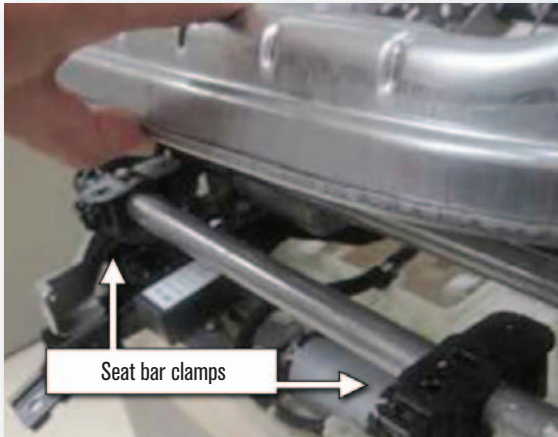
Lubricate both ends of the seat pan bar and the interior surfaces of both clamps.

10. Remove the clamps and use a quality grease to lubricate both ends (left and right sides) of the seat pan bar as indicated in the photo.

11. Lubricate interior surfaces of both clamps (left and right sides) as indicated in the photo.

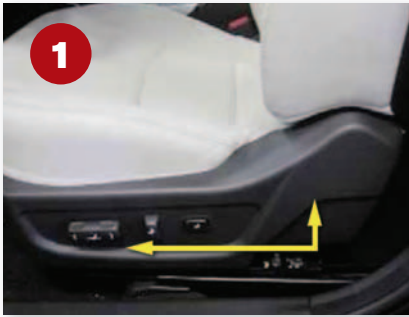
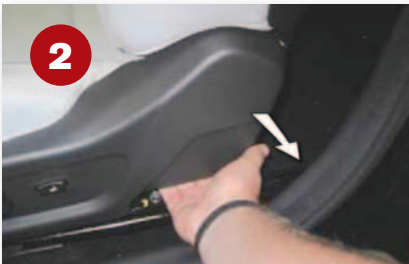
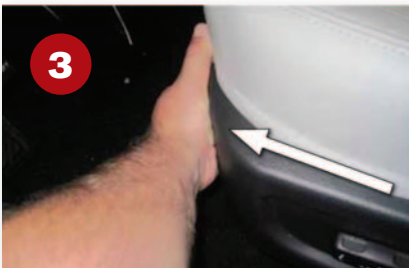
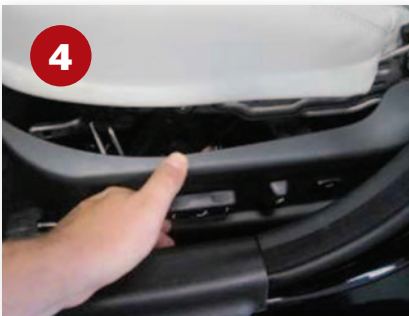
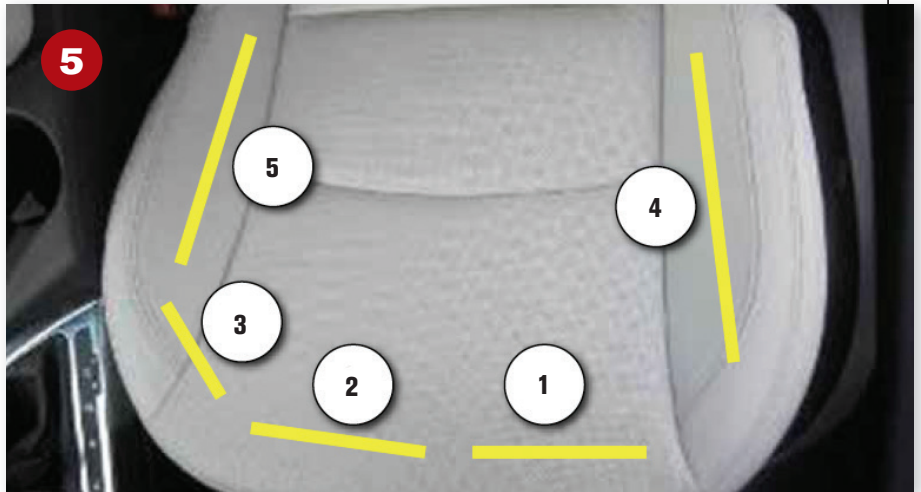
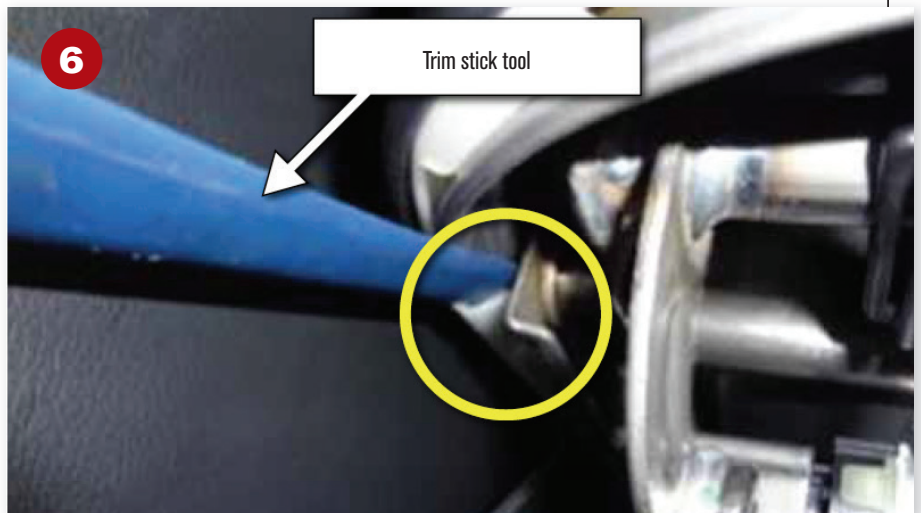
Driver's Seat Pan Bar Lubrication Service Procedure

- 1.** Move the seat forward and move upward to maximum position.
- 2.** Use your hand to disconnect the first tab only. Apply a light pulling force at the lower rear portion of the side trim cover, pulling trim piece towards you.
Caution: Be careful not to damage the side cover during removal.
- 3.** Push/pull the front of the cover forward to release from mounting tab.

- 4.** With the wire harness still connected to the seat cover, move the seat back in order to access the seat cushion mounting j-clips.
- 5.** Remove the cushion mounting j-clips (#1- 4) from the seat frame. (Remove the front j-clip first for easier removal). The locations of the j-clips are highlighted (yellow lines) in the photo.
Notice: Remove seat cushion and clips in

- numerical sequence (1~5) as indicated in the photo.*
- 6.** Insert trim stick tool to remove j-clip #5 nearest to center console.
- 7.** With the cushion mounting j-clips removed, lift the cushion to expose the seat pan.
- 8.** With the cushion lifted, remove the four seat pan fasteners.

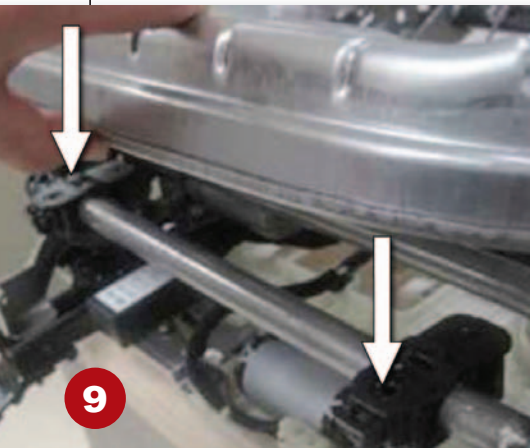
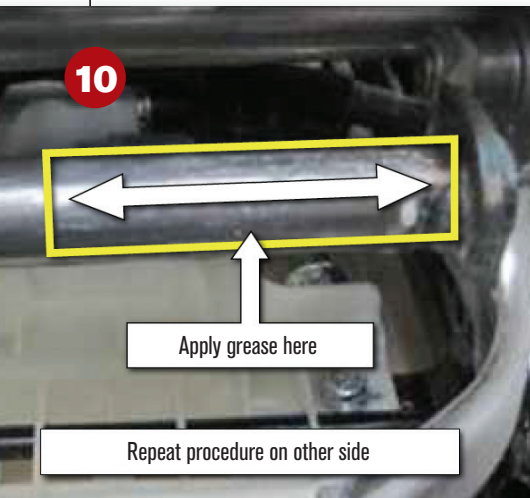
9. Raise the seat pan to access the two seat bar clamps as indicated by the arrows.

Notice: Use a high quality non-dripping grease such as Red Crown grease or a lithium based grease.

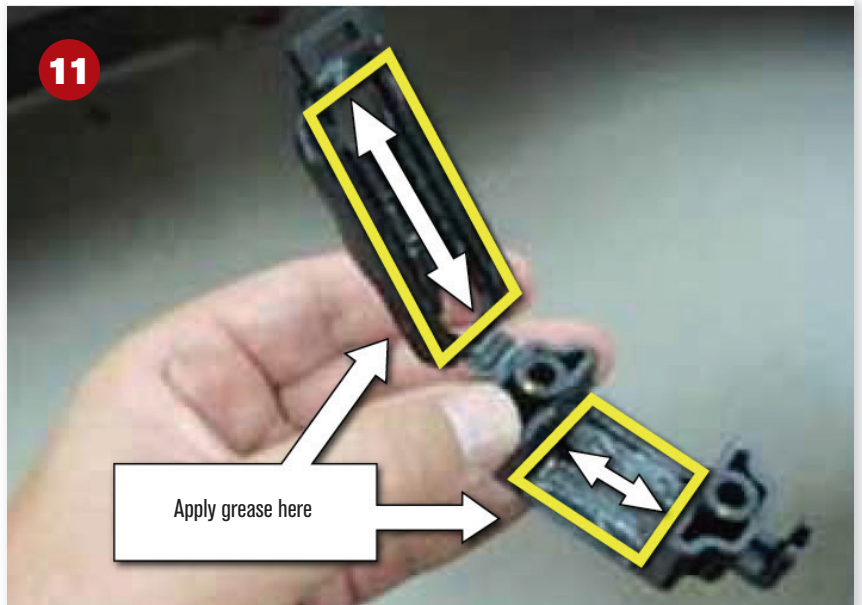
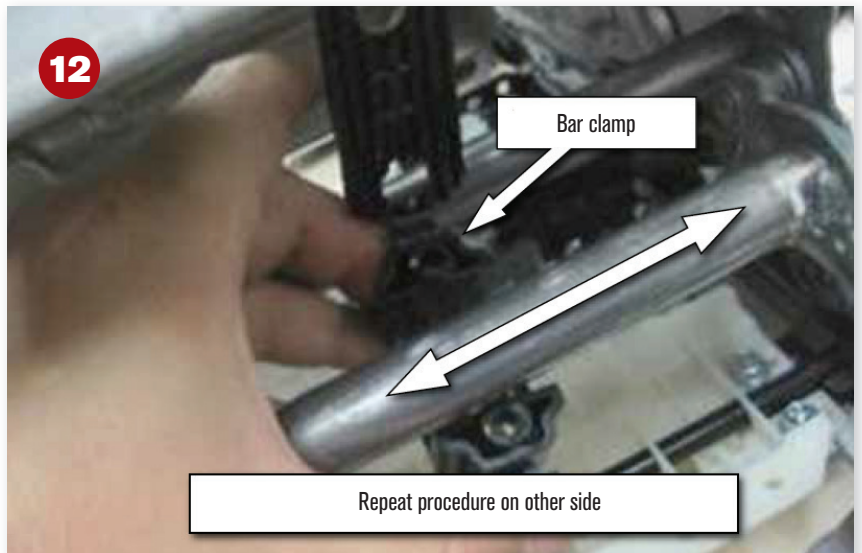
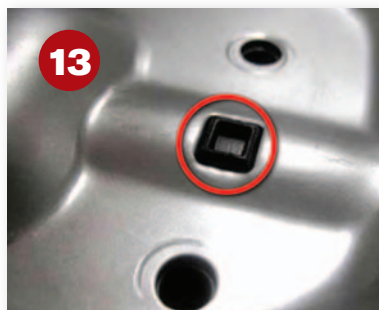
12. Reinstall both bar clamps (left and right sides) and slide the bar clamp back and forth to spread grease evenly.

13. Lower the seat pan back onto the seat pan bar and ensure the square tab on the top of clamp goes into the square opening on seat pan.

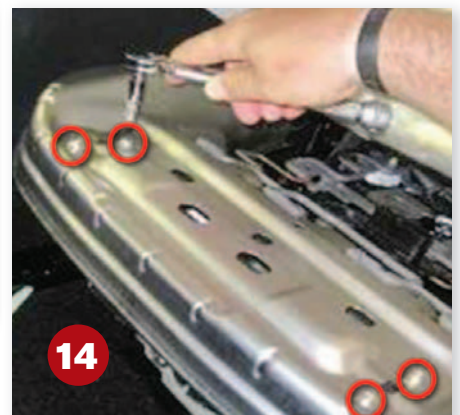
14. Reinstall all four fasteners (red circles), and tighten using a torque wrench. Torque specification: 2.2 ft-lbs,

26.4 in-lbs (3 Nm). Reassemble the seat cushion and seat side cover in reverse order of removal. Verify that the concern has been corrected. **KIA**
